Asbestos Survey Report

**445 East Springfield Road
St. Clair, Missouri**

Project No. 16-6412

May 9, 2016

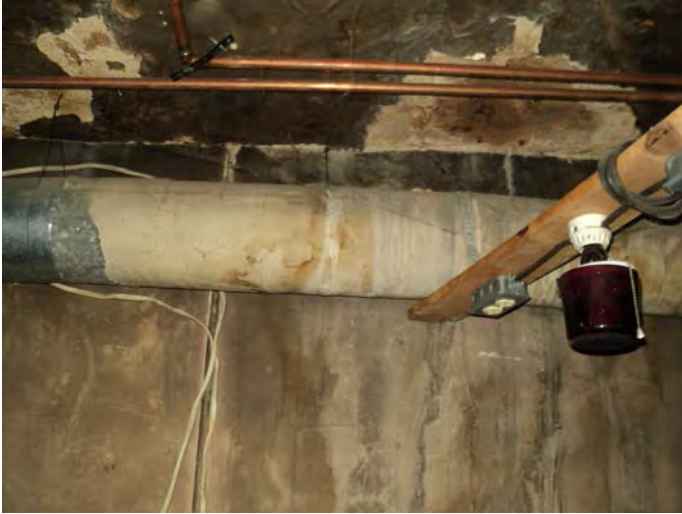
Material	Location	Amount & Type of ACM	Friable (F) Non-Friable (NF)	Quantity	Condition
Insulation wrap around duct work (12a)	Workshop/garage	85-90% Chrysotile	NF	+/- 100 lineal feet	Fair
9x9 brown floor tile (13a)	Workshop/garage office area	5-10% Chrysotile	NF	+/- 225 sq ft	Fair

1. Insulation wrap around duct work in workshop/garage.

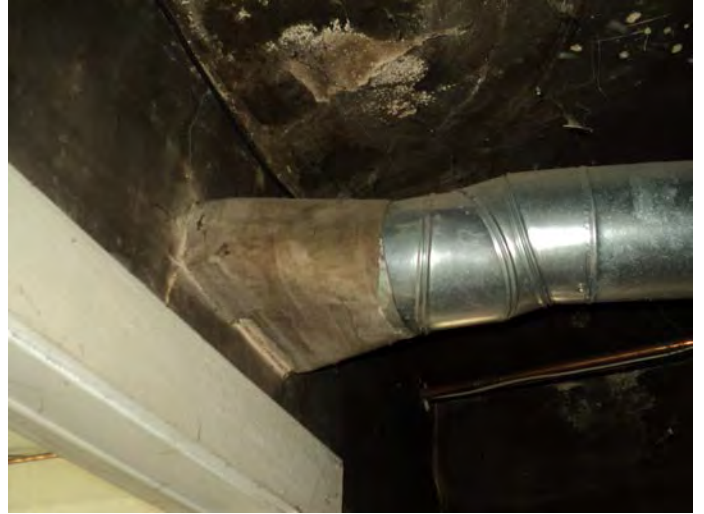
2. Insulation wrap around duct work in workshop/garage.

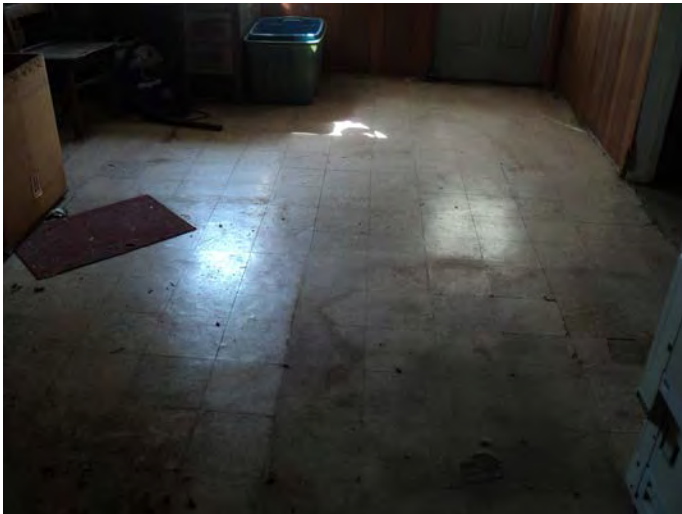
3. 9x9 floor tile in office area in workshop/garage.

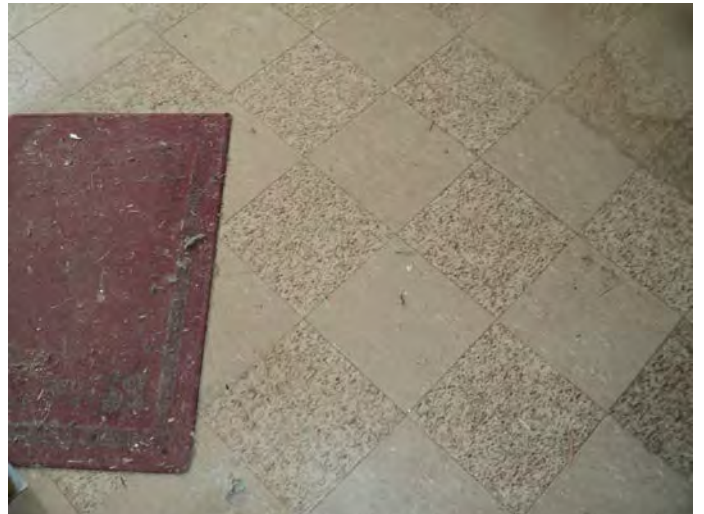
4. 9x9 floor tile in office area in workshop/garage.
